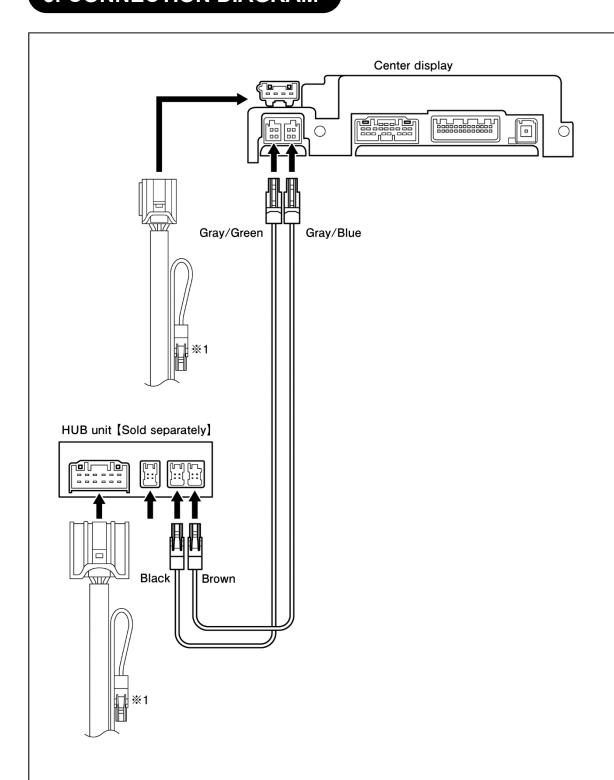
# 3. CONNECTION DIAGRAM

\*1: To prevent noise, wrap the disconnected vehicle wiring harness connector with a piece of sponge tape (100 x 30 mm).

The diagram shows the case when there is a single vehicle wiring harness connector.

If there are two vehicle wiring harness connectors, carry out the same procedure for both connectors.

- Reinstall parts in the reverse order of the installation procedure in "VEHICLE PARTS REMOVAL".
   (Refer to "3. CONNECTION DIAGRAM" on P.4 for details on connecting the USB cable connector.)
- 2. Refer to "Required servicing after disconnecting/connecting negative battery cable" in the vehicle workshop manual or the owner's manual to restore the vehicle functions.
- Perform reinstallation and inspection of the vehicle parts.
   Refer to "5. OPERATION CHECK on P5 to carry out an operation check.

- 1. Reinstall parts in the reverse order of the installation procedure in "VEHICLE PARTS REMOVAL". (Refer to "3. CONNECTION DIAGRAM" on P.4 for details on connecting the USB cable connector.)
- 2. Refer to "Required servicing after disconnecting/connecting negative battery cable" in the vehicle workshop manual or the owner's manual to restore the vehicle functions.
- Perform reinstallation and inspection of the vehicle parts.
   Refer to "5. OPERATION CHECK on P5 to carry out an operation check.

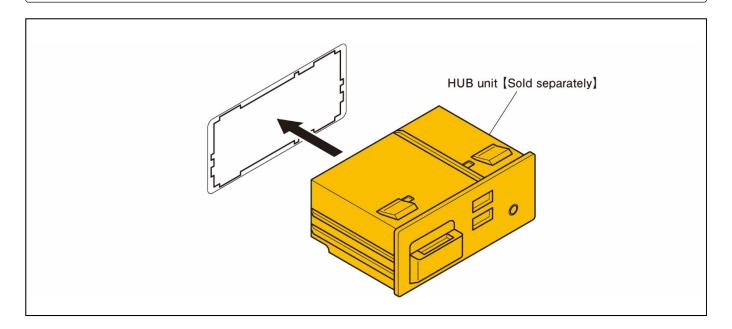
## 4. HUB UNIT INSTALLATION

1. Remove the AUX unit from the vehicle, and then install the HUB unit (sold separately).

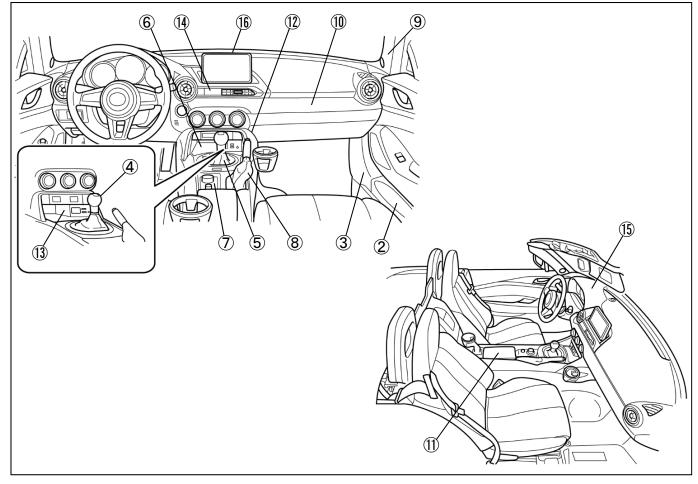
Remove the following vehicle parts.

- 1 Negative battery cable disconnection
- 2 Passenger-side scuff plate
- 3 Passenger-side front side trim
- 4 Shift lever knob (MT) or Selector lever knob (AT)
- **5** Shift panel
- **6** Console panel
- **7** Upper panel
- **8** Parking brake lever boots panel
- 9 Passenger-side A-pillar trim
- **10** Passenger-side lower panel
- **11** Rear console
- Tront console panel
- (13) Front console
- (4) Center panel No.2
- **15** Meter hood
- (16) Center display

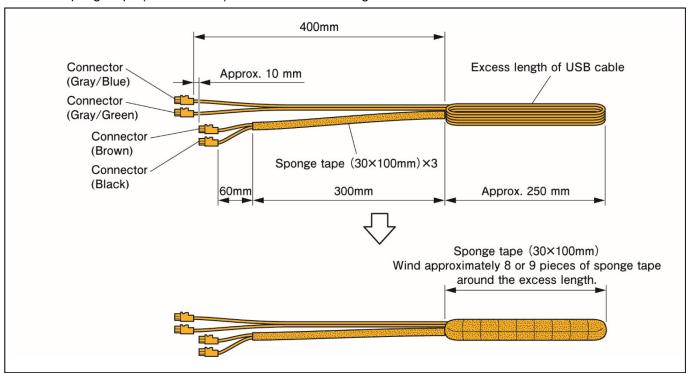
- Winding sponge tape
- 1. Bind the excess length of USB cable as shown in the diagram below.
- 2. Wind sponge tape (100 x 30 mm) around the excess length of USB cable.

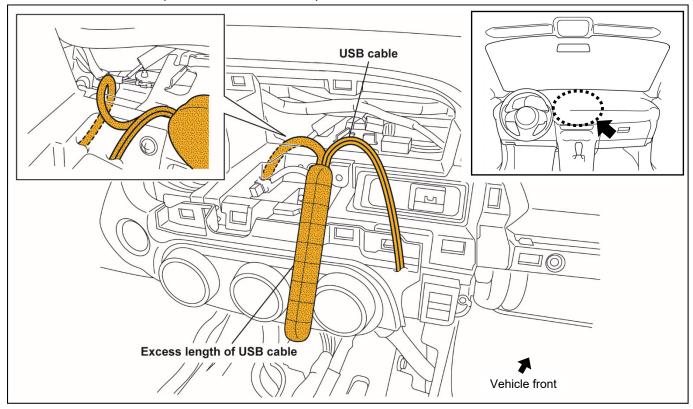
1. Route the USB cable (brown or black connector) to the underside of the front console.

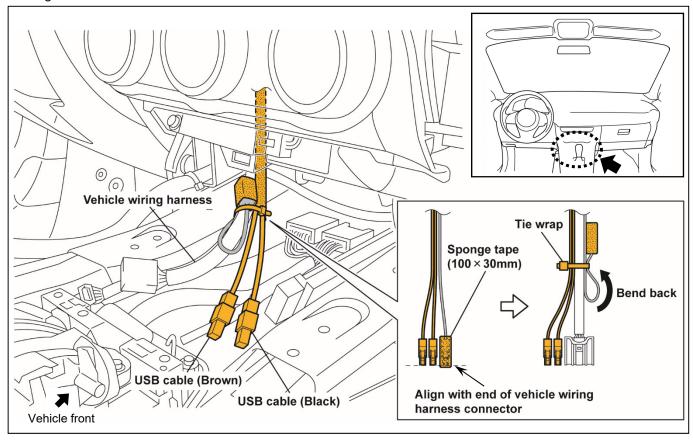
- 2. To prevent noise, wrap the disconnected vehicle wiring harness connector with a piece of sponge tape (100 x 30 mm).
- 3. Align the ends of the vehicle wiring harness connector and the USB cable connector.
- 4. Bend back the vehicle wiring harness connector, and then use a tie wrap to secure the vehicle wiring harness together with the USB cable.

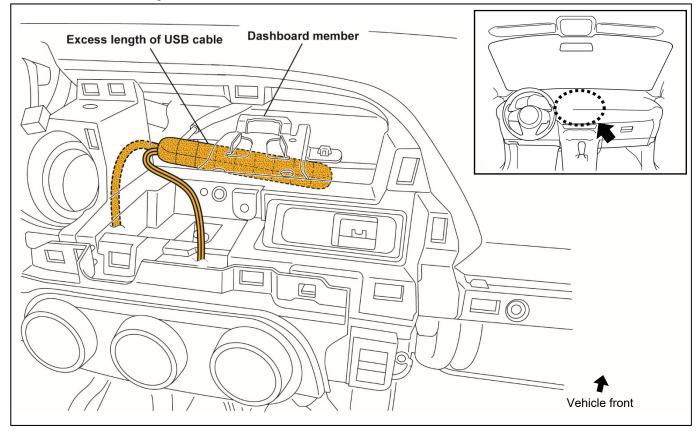
5. Push the excess length of USB cable under the dashboard member.

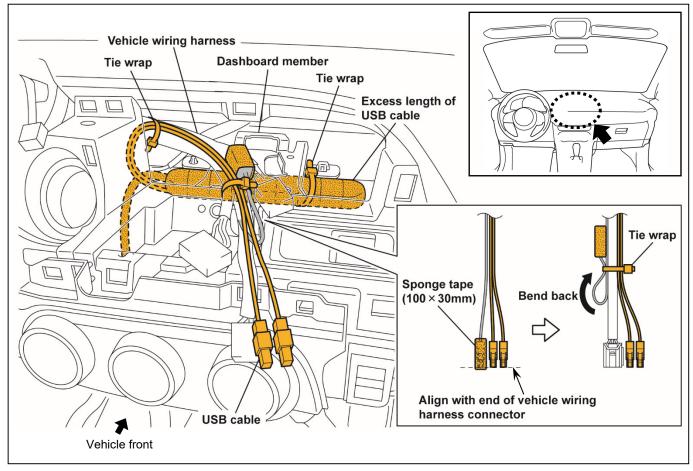
- 6. To prevent noise, wrap the disconnected vehicle wiring harness connector with a piece of sponge tape (100 x 30 mm).
- 7. Align the ends of the vehicle wiring harness connector and the USB cable connector.
- 8. Bend back the vehicle wiring harness connector, and then use a tie wrap to secure the vehicle wiring harness together with the USB cable.
- 9. Secure the USB cable to the vehicle wiring harness with a tie wrap.
- 10. Secure the excess length of USB cable to the dashboard member with a tie wrap.

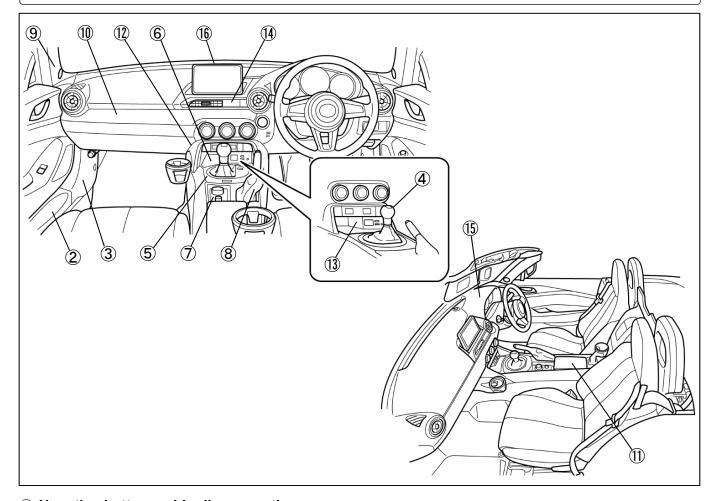
Remove the following vehicle parts.

- 1 Negative battery cable disconnection
- 2 Passenger-side scuff plate
- 3 Passenger-side front side trim
- 4 Shift lever knob (MT) or Selector lever knob (AT)
- **5** Shift panel
- **6** Console panel
- **7** Upper panel
- **8** Parking brake lever boots panel
- 9 Passenger-side A-pillar trim
- **10** Passenger-side lower panel
- **11** Rear console
- Tront console panel
- (13) Front console
- (4) Center panel No.2
- **15** Meter hood
- (16) Center display

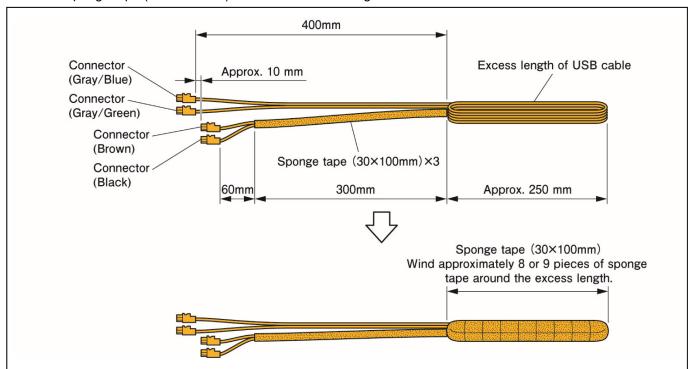
- Winding sponge tape
- 1. Bind the excess length of USB cable as shown in the diagram below.
- 2. Wind sponge tape (100 x 30 mm) around the excess length of USB cable.

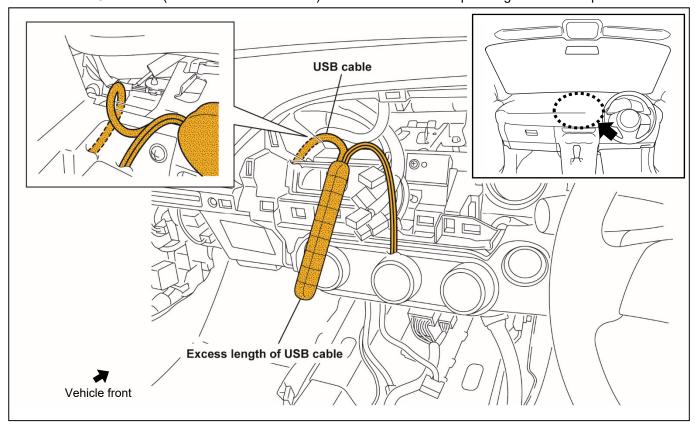
1. Route the USB cable (brown or black connector) to the underside of the passenger-side lower pane.

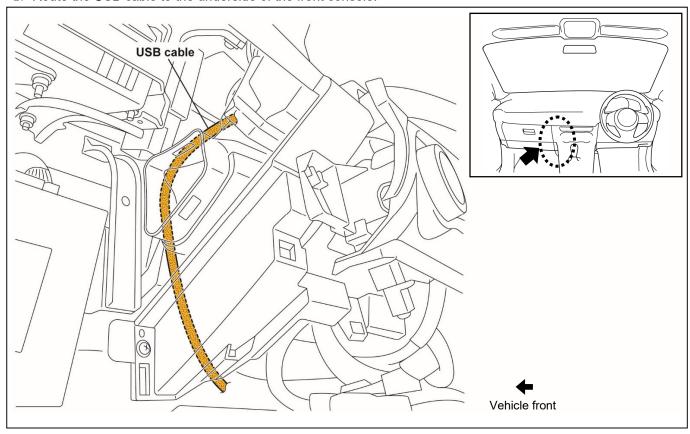
2. Route the USB cable to the underside of the front console.

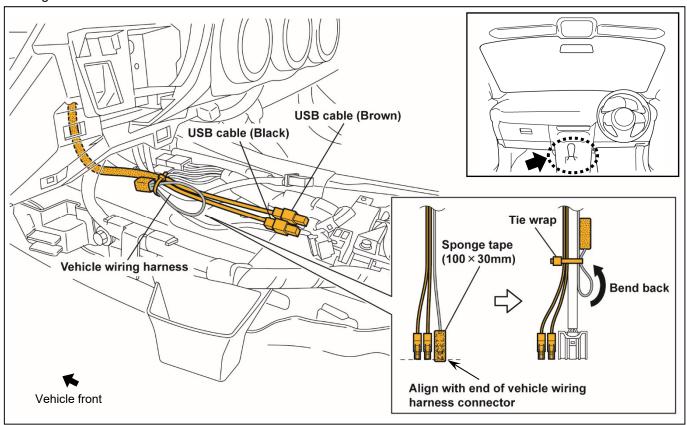
- 3. To prevent noise, wrap the disconnected vehicle wiring harness connector with a piece of sponge tape (100 x 30 mm).
- 4. Align the ends of the vehicle wiring harness connector and the USB cable connector.
- 5. Bend back the vehicle wiring harness connector, and then use a tie wrap to secure the vehicle wiring harness together with the USB cable.

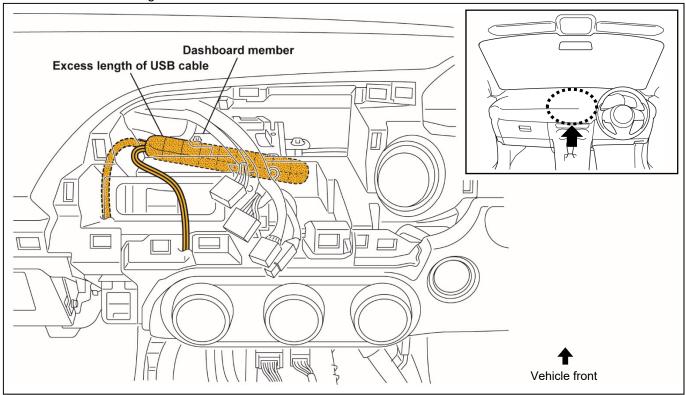
6. Push the excess length of USB cable under the dashboard member.

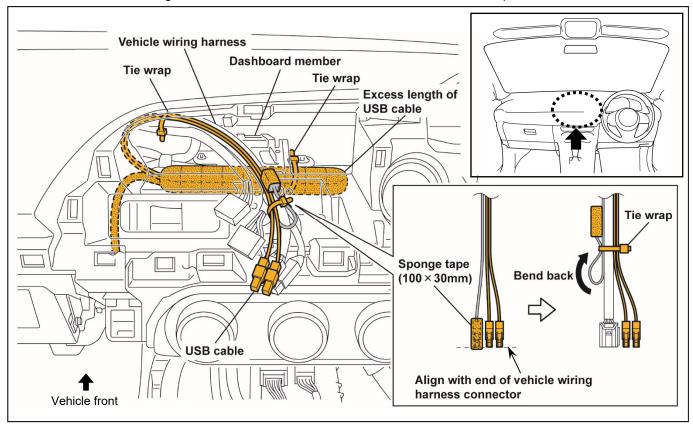
- 7. To prevent noise, wrap the disconnected vehicle wiring harness connector with a piece of sponge tape (100 x 30 mm).
- 8. Align the ends of the vehicle wiring harness connector and the USB cable connector.
- 9. Bend back the vehicle wiring harness connector, and then use a tie wrap to secure the vehicle wiring harness together with the USB cable.
- 10. Secure the USB cable to the vehicle wiring harness with a tie wrap.
- 11. Secure the excess length of USB cable to the dashboard member with a tie wrap.
